Manhole Inspection Summary

Manhole # S45E2_015MH

Location Address: **3933 Inner Cir**

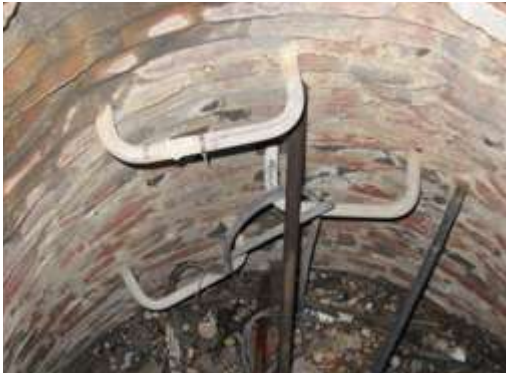
Steps Count: **3** Missing: **0** ☐ Corroded

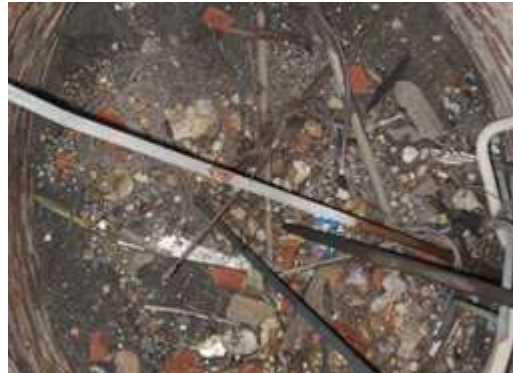
Defect 2

Condition: ☐ Sound ☐ Cracked ☐ Root Intrusion ☐ Deteriorated ☐ Leaks ☒ **Debris**

Debris/poles

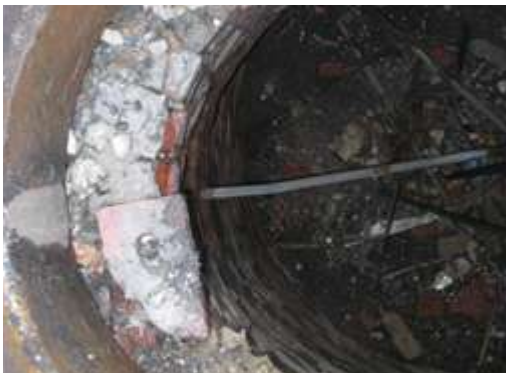
Defect 1

Frame Offset: **4** (in.) Condition: ☒ Sound ☐ Cracked ☐ Leaks

Frame offset

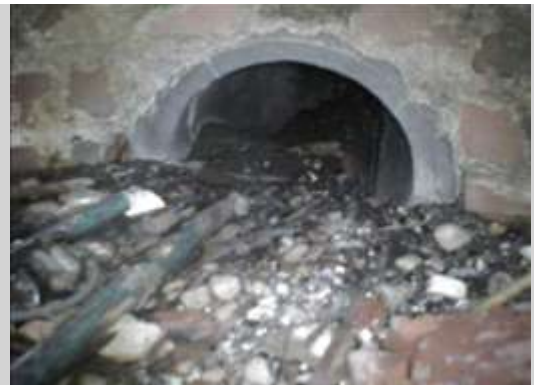
12 O'Clock Outflow

8 in. Circular Gravity Sewer
Pipe Out @ 12 O'Clock

Infiltration: **None** Pipe Seal Cond: **Sound**
